Manhole Inspection Summary

Manhole # S33G__027MH

Insp Date: **9/12/08 1:41 PM**

Location Address: **11 Cider Al**

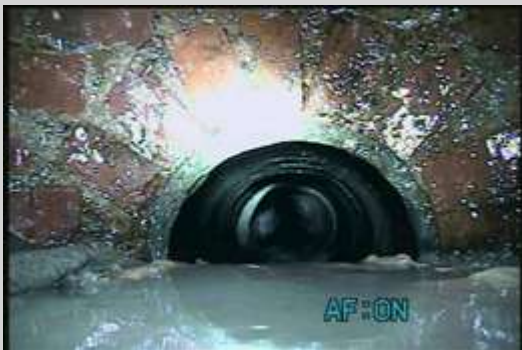
12 O'Clock Outflow

10 in. Circular Gravity Sewer
Pipe Out @ 12 O'Clock

Invert Depth: **10.16** (ft.) Flow Characteristics: **Fast**

Deposits: ☒ None ☐ Mud ☐ Sludge ☐ Debris ☐ Grease

Infiltration: **None** Pipe Seal Cond: **Unknown**

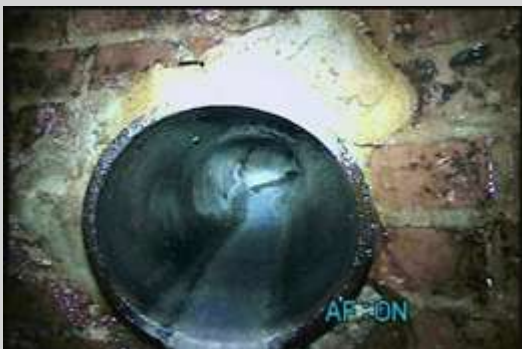
7 O'Clock Inflow

6 in. Circular Gravity Sewer
Pipe In @ 7 O'Clock

Infiltration: **None** Pipe Seal Cond: **Unknown**
